INSTRUCTIONS SAT

After Sales Department (SAT)

**REPLACE RUBBER BELLOWS IN UTE-170 (INSULATOR D) MODEL
INDUCTIVE VOLTAGE TRANSFORMER**

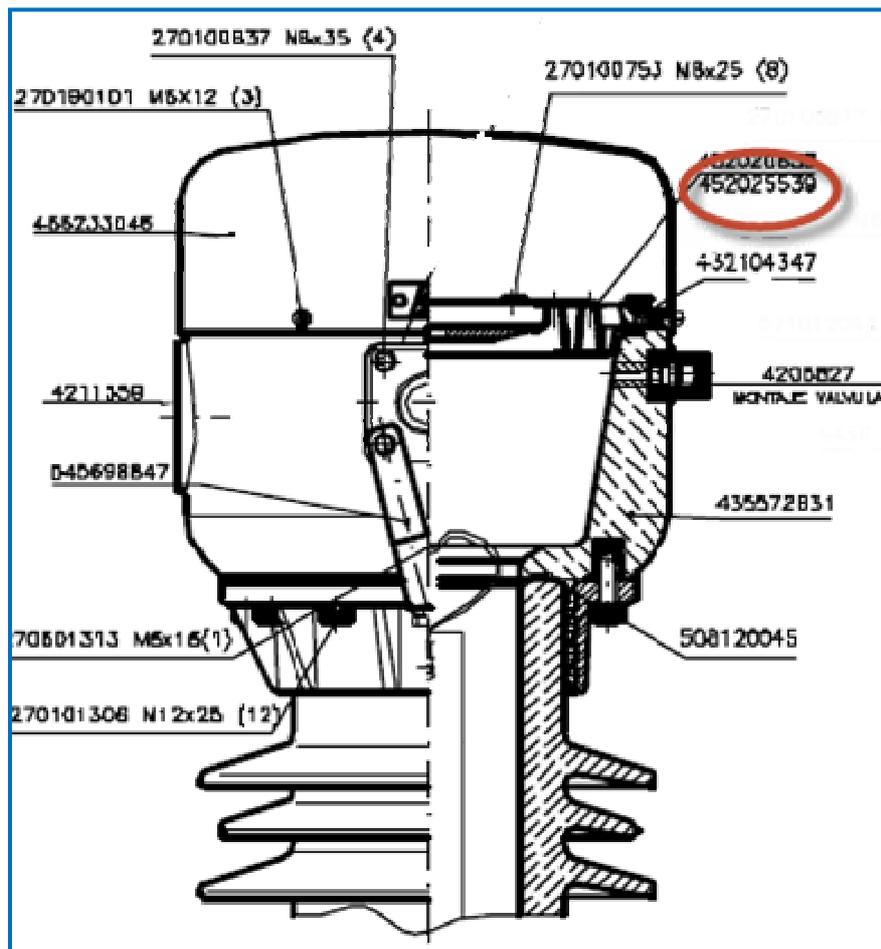
FIGURE 1:

The process will be to replace the rubber bellows (code 452025539) used to compensate the oil volume variations from Figure 1, by the new rubber bellows (code 452025638) and the new aluminium flange (code 553611245) seen in Figure 2.

Figure	Code	Material
Figure 1	452025539	Rubber bellows to be replaced
Figure 2	452025638	New rubber bellows
Figure 2	553611245	New aluminium flange

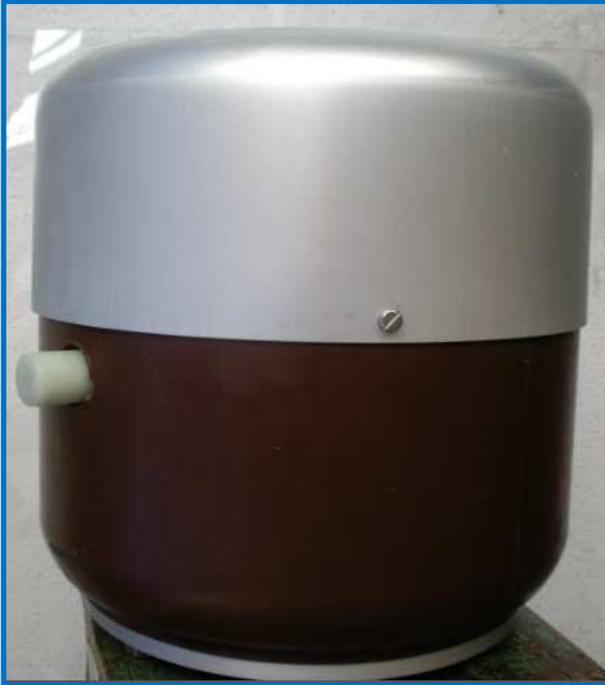
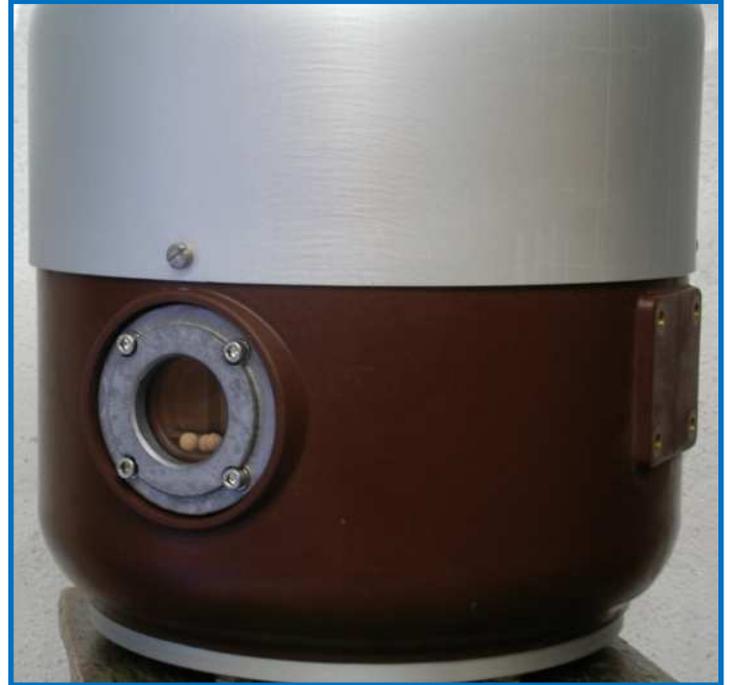
1. View of the head of the VT, where the rubber bellows are housed.

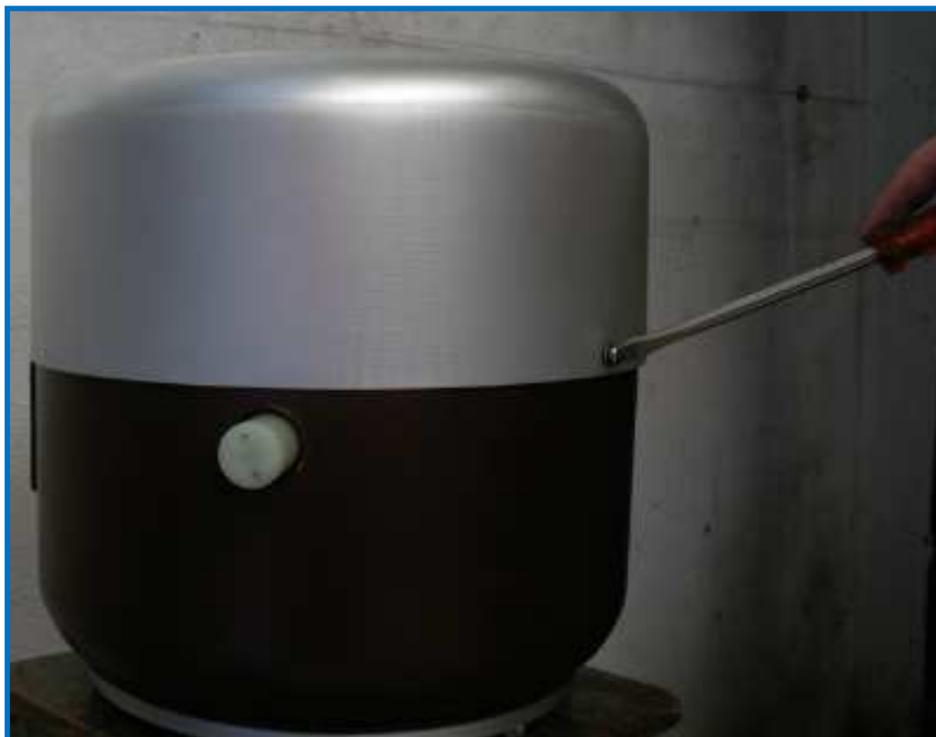
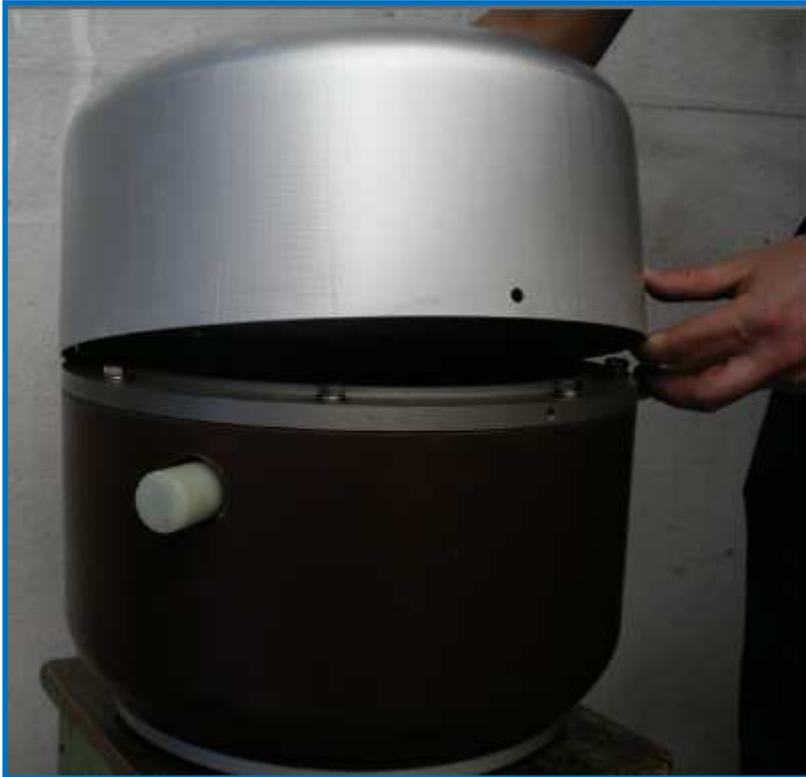
2. Loosen the screws that hold the cover to the head.

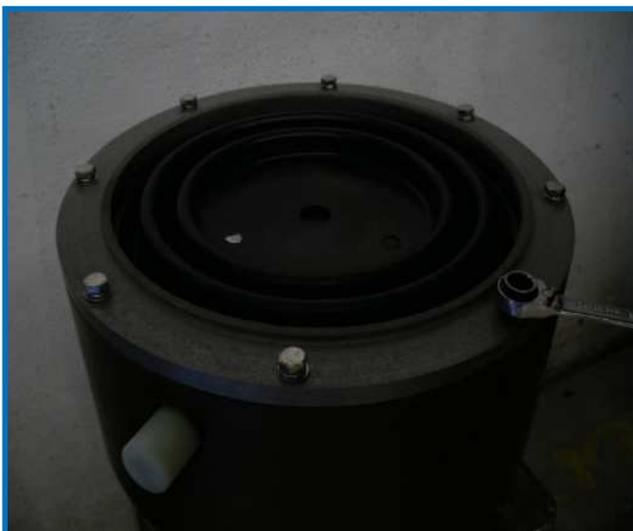
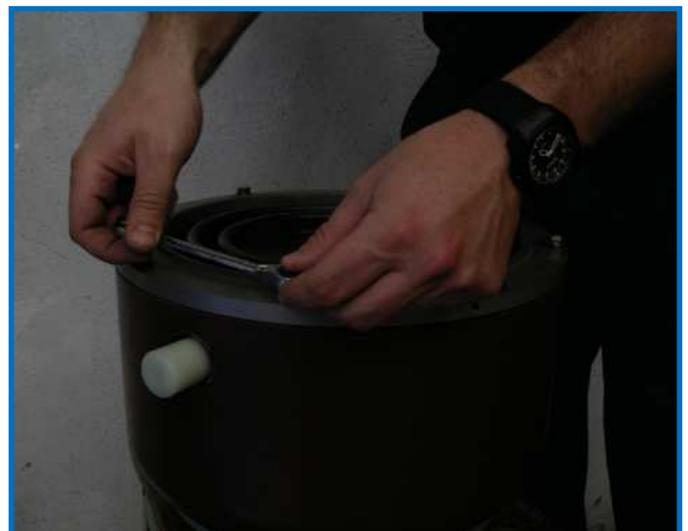
3. Once the cover is removed, loosen the M8 screws that hold the aluminium flange (code 432104347) which at the same time is holding by pressure the rubber bellows in place.

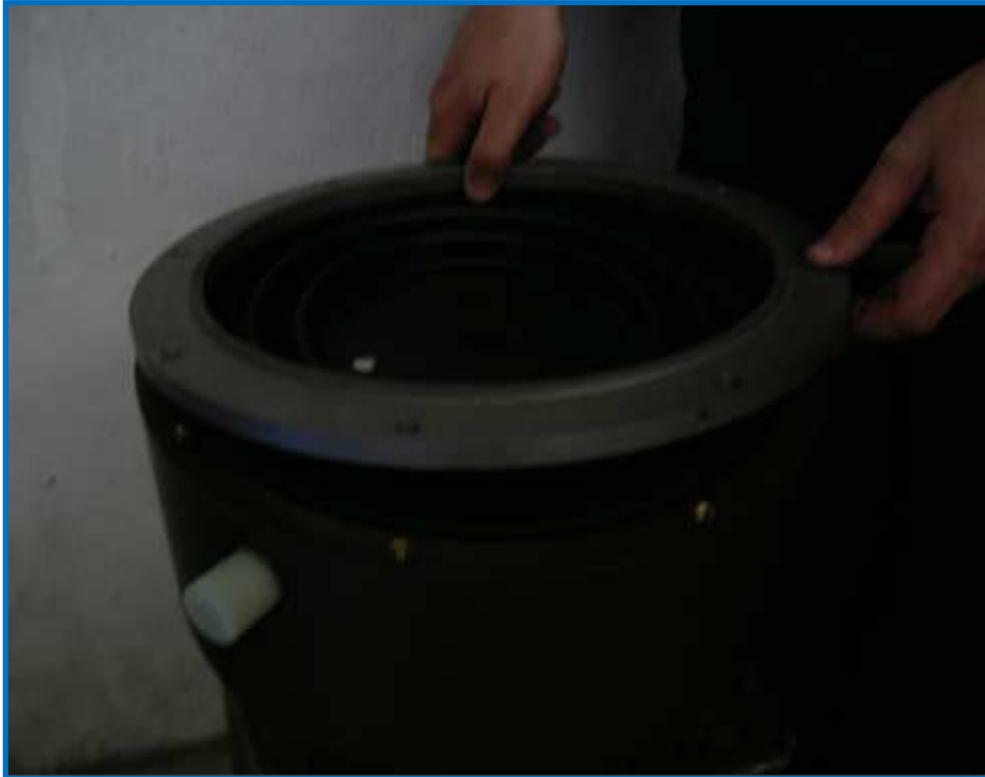
4. Remove the aluminum flange (code 432104347).

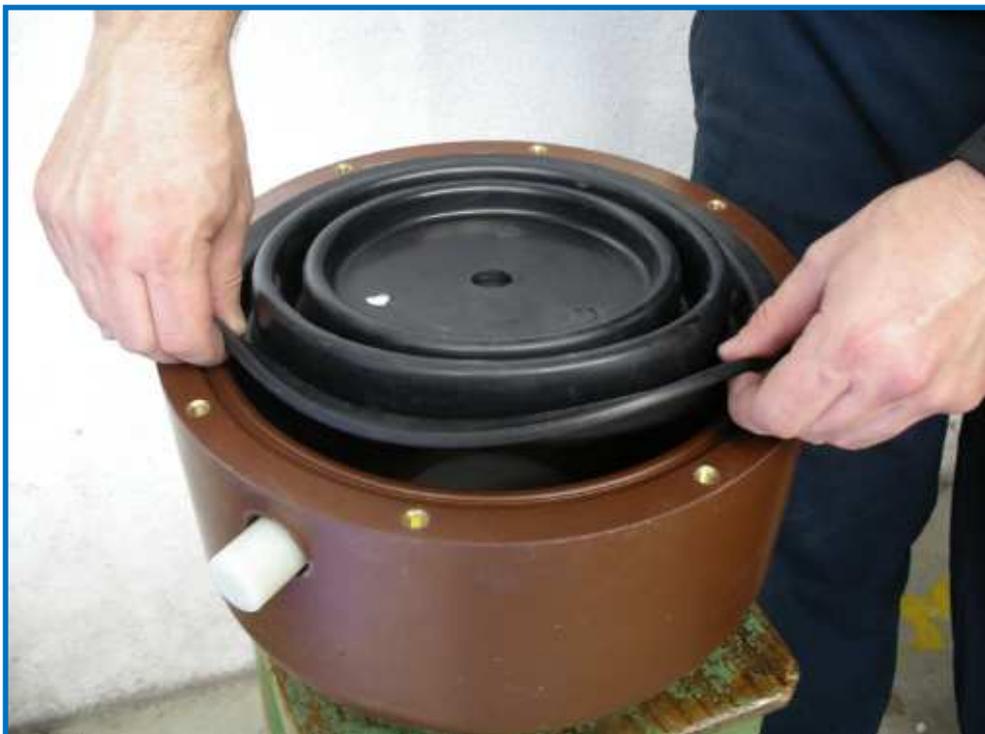
5. Remove the rubber bellows (code 452025539) by hand, with a quick movement, to avoid any part of it sinking into the oil.

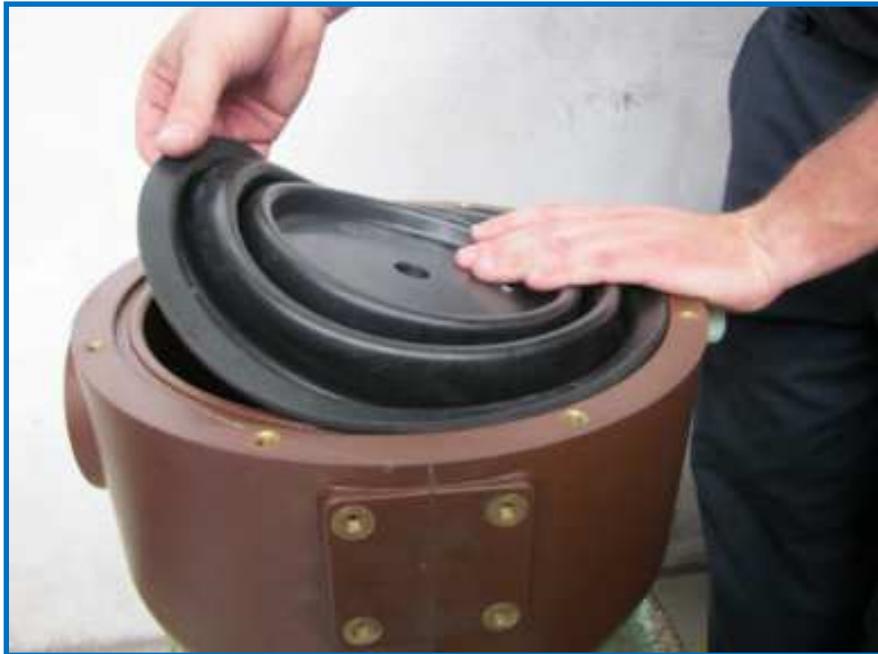
6. Place the new rubber bellows (code 452025638) as seen in the photo, applying pressure with one hand in the central part, forcing it to be in contact with the oil, while at the same time allowing the air to flow out the open part.

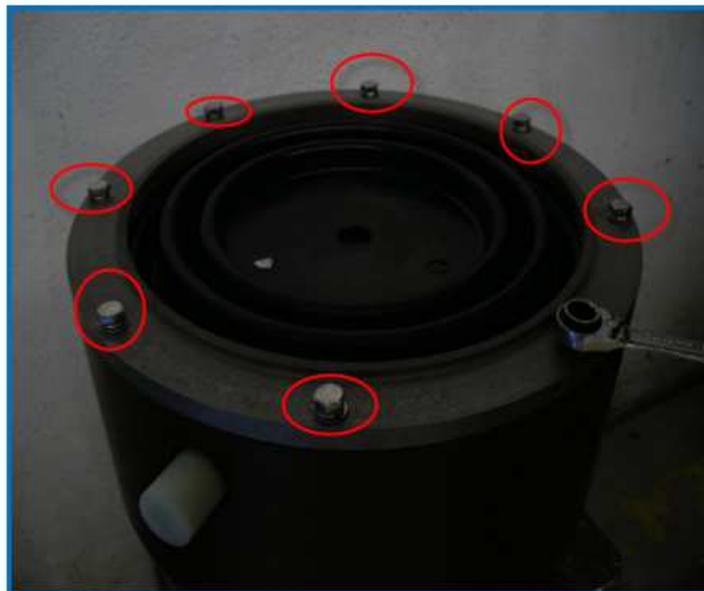
7. Fix the M8 screws to 20 Nm. that hold the aluminium flange which at the same time is holding by pressure the new aluminium flange and the new rubber bellows in place.

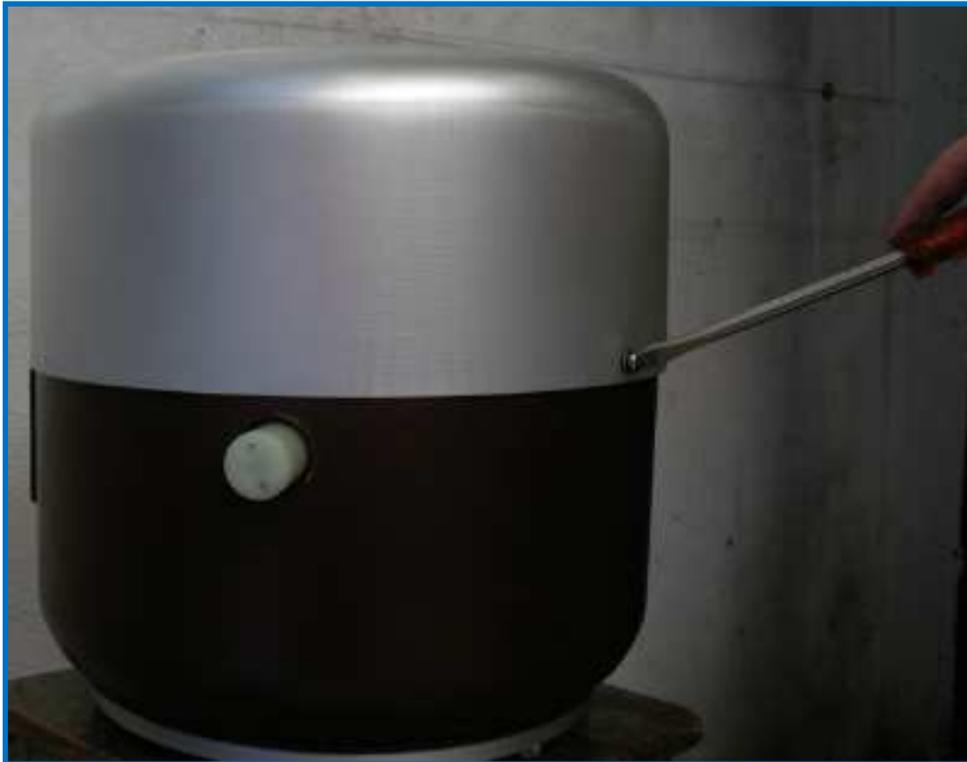
8. Place the cover again and fix the screws.
